1. Door Glass

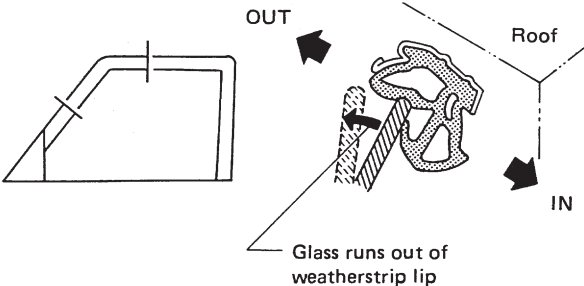
Condition	Apparent cause/Correction
<p>Glass in fully closed position</p>	<p>1) Glass runs out of weatherstrip lip when considerable hand pressure is applied to it from inside.</p>

<p>G5M0502</p> <p>(This condition may cause wind/booming noise during high- speed operation.)</p>	<ul style="list-style-type: none"> <li>● Insufficient upward travel of glass Increase upward travel of glass.</li> </ul>
	<p>2) Clearance exists between glass and weatherstrip when light hand pressure is applied to it at center and rear pillar locations.</p>

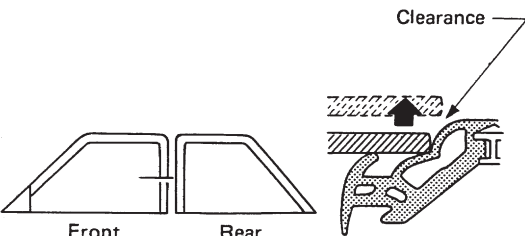
<p>G5M0503</p> <p>(This condition may cause wind noise and/or water leakage.)</p>	<ul style="list-style-type: none"> <li>● Insufficient glass-to-door weatherstrip contact Check stabilizer and glass for proper contact. Increase contact using upper sash adjustment bolt.</li> <li>● Insufficient glass-to-door weatherstrip contact Check stabilizer and glass for proper contact. Increase contact using upper sash adjustment bolt.</li> </ul>

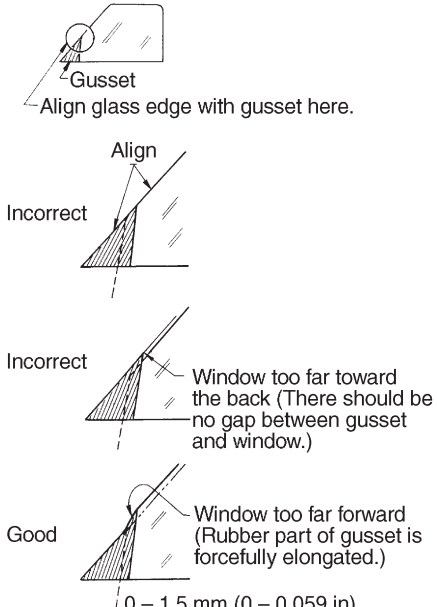
<p>3) Adjust door glass so that it is aligned with door rearview mirror gusset</p>

<p>Gusset Align glass edge with gusset here.</p> <p>Align</p> <p>Incorrect</p> <p>Incorrect</p> <p>Window too far toward the back (There should be no gap between gusset and window.)</p> <p>Good</p> <p>Window too far forward (Rubber part of gusset is forcefully elongated.)</p> <p>0 – 1.5 mm (0 – 0.059 in)</p> <p>H5M0672A</p>	<ul style="list-style-type: none"> <li>● Window is not properly adjusted in up-down/fore-aft direction. Adjust window. If necessary, move “B” channel for regulator to eliminate window “tilt”.</li> <li>● Gusset is not properly adjusted in fore-aft direction. Adjust gusset after loosening all bolts and nuts with tightening it.</li> </ul>

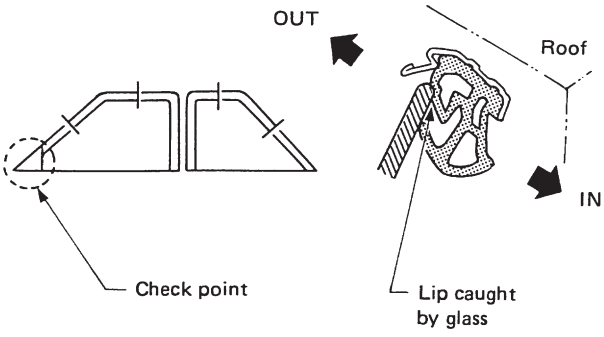
Condition	Apparent cause/Correction
<p>Door in fully closed/ open position</p>	<p>1) Glass rides over weatherstrip lip when door is closed.</p>

<p style="text-align: right;">G5M0505</p> <p>(This condition increases wind/booming noise, leakage and/or effort required to close door.)</p> <p>2) Edge of glass contacts retainer when door is fully closed.</p>

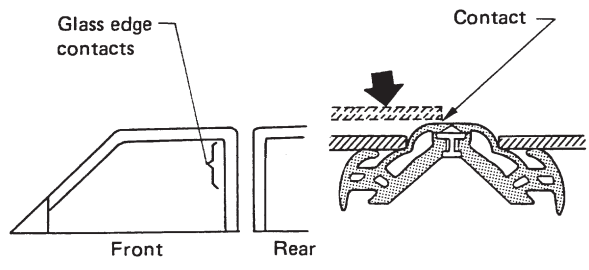
<p style="text-align: right;">G5M0506</p>	<ul style="list-style-type: none"> <li>● Improper up-down and in-out glass alignments Adjust glass for up-down and in-out alignments (incl. rear sash, upper stopper adjustment, etc.). If necessary, correct glass tilt by moving regulator "B" channel.</li> <li>● Improper glass-to-center pillar weatherstrip or excessive glass contact to weatherstrip Excessive adjusting in contact to weatherstrip causes rear edge of glass to tilt inboard closer to center pillar. Adjust rear sash adjustment bolt to reduce glass contact to weatherstrip.</li> </ul>

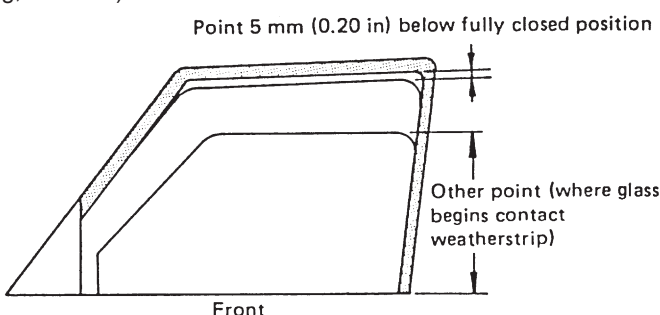
<p>Raise or lower window glass</p>	<p>1) Considerable effort or time is required to operate regulator. Standard operating effort:</p> <ul style="list-style-type: none"> <li>● Entire up-down travel except for point 5 mm (0.20 in) below fully closed position: 29.4 N (3.0 kg, 6.6 lb)</li> <li>● Point 5 mm (0.20 in) below fully closed position: 45.0 N (4.5 kg, 10.12 lb)</li> </ul>

<p style="text-align: right;">G5M0507</p>	<ul style="list-style-type: none"> <li>● Sliding resistance increased due to high stabilizer-to-glass contact pressure Reduce contact by mounting inner stabilizer to inside of the car.</li> <li>● High glass-to-windshield contact pressure Reduce contact using upper sash adjustment bolt.</li> <li>● Unequal contact adjustment stroke between front and rear sashes Set to equal stroke.</li> <li>● Tilt of rear sash adjustment bolt mounting bracket Correct tilt of bracket so it is parallel to inner panel.</li> </ul>

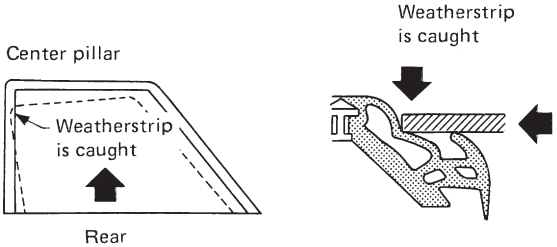
Condition	Apparent cause/Correction
<p>Raise or lower window glass</p>	<p>2) Center pillar weatherstrip is caught by rear window glass when glass is raised.</p>

<p style="text-align: right;">G5M0508</p>	<ul style="list-style-type: none"> <li>● Improper fore-aft or in-out alignment of window glass</li> </ul> <p>Lower regulator "B" channel to tilt window glass back.</p>
	<p>3) Glass tilts forward by more than 2 mm (0.08 in).</p>

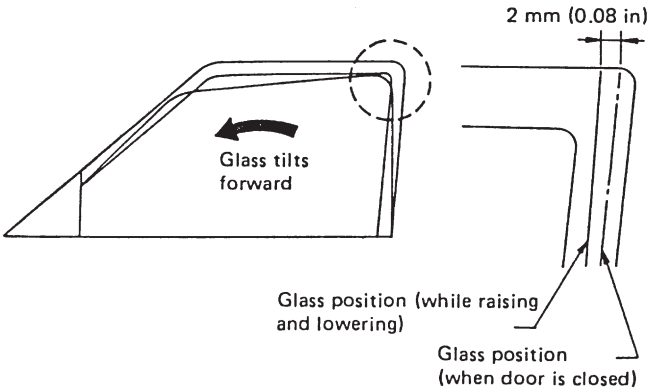
<p style="text-align: right;">G5M0509</p> <p>(Excessive tilt of glass forward is due to excessive glass "contact" which causes reaction of center pillar weatherstrip.) Glass can be tilted forward due to increase in reaction of shoulder weatherstrip or free play between sash and roller. Taking these symptoms into account, glass should be aligned.</p>	<ul style="list-style-type: none"> <li>● Excessive glass contact pressure or improper in-out alignment</li> </ul> <ol style="list-style-type: none"> <li>1) Lower regulator "B" channel to tilt glass rearward.</li> <li>2) Reduce contact pressure using upper sash adjustment bolt.</li> </ol>
